NATIONAL TRANSPORTATION SAFETY BOARD
OFFICE OF AVIATION SAFETY
WASHINGTON, D.C.

SYSTEMS AND POWERPLANTS GROUP CHAIRMAN'S FACTUAL
REPORT OF INVESTIGATION

A. ACCIDENT : MIA99FA245

AIRCRAFT : Beachcraft B90 King Air, N338AS, Operated by CP
Horizons, Inc.

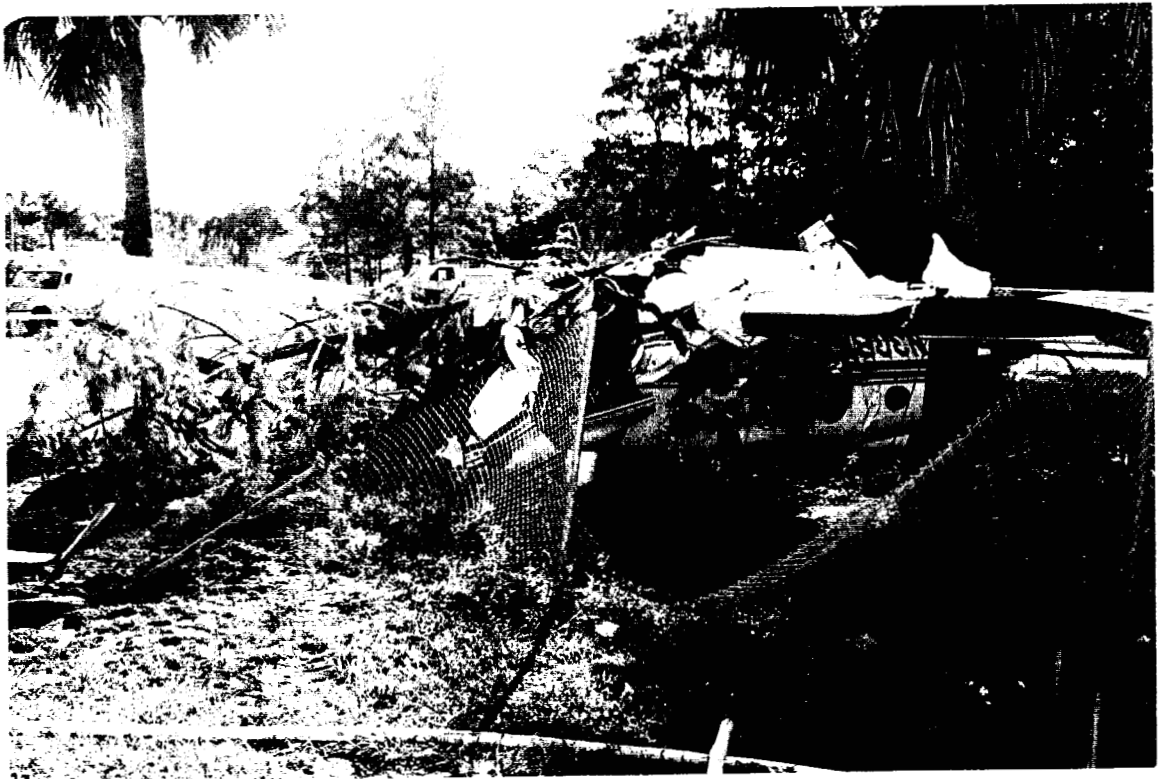
3. AIRCRAFT FUSELAGE

The airplane was found inverted with its right wing resting on a fence. The fuselage was found fire damaged with the floor of the cabin consumed by fire. The main landing gear assemblies were found in the extended position but the struts including the wheel assemblies were separated from the main cylinders. The nose gear strut cylinder and extension assembly was separated from the fuselage attach points and in an extended position. The nose gear strut and wheel assembly were separated from the strut cylinder. The radar assembly and its mounting points were separated and found with the nose gear structure assembly near the front of the fuselage. The lower forward fuselage was crushed from the nose radome aft to the wing root. The remainder of the lower forward fuselage was 50% consumed by fire and torn from the fuselage during recovery.

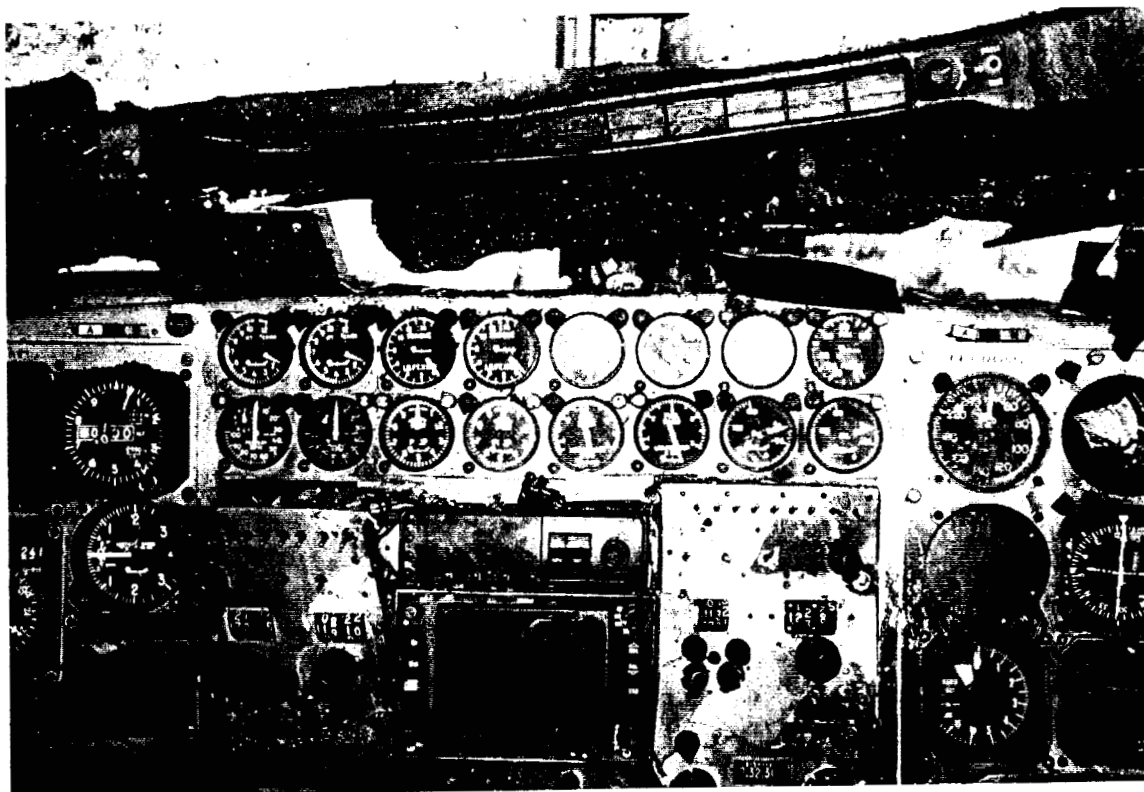
10.ENGINE INSTRUMENTS

The cockpit instruments were found integral to their respective mounting structure and had soot covering the outside glass instrument faces. The engine instruments were indicating zero with the exception of the left fuel flow gauge which indicated about 280 pounds per hour. The flight instruments indicated that the airplane heading was 130 degrees, airspeed zero, altitude 50 feet, and an attitude of pitch level with a 15 degree left bank. The fuel quantity gauges indicated zero.
